Blue Valley School District 2018 District-Wide Crosswalk Study

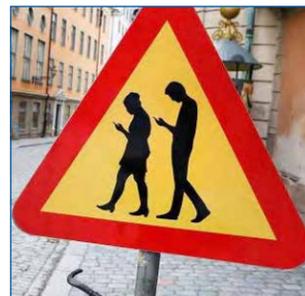
Figure 1.2: European crossing signs.

- ▶ Addition of signing to warn drivers that pedestrians are looking at their phones. (Europe)
- ▶ In pavement LED lights that get a pedestrian’s attention as they approach a crossing. (Germany)
- ▶ Painting portions of sidewalk prior to the crosswalk to catch the pedestrians attention. (Many locations across the US, similar to the Eyes Up Phone Down messaging shown in Figure 1.3)
- ▶ Fines ranging from \$25 to \$100 for using a cell phone while in the crosswalk. (California, Chicago, Hawaii)
- ▶ The “Look Up” app was created to notify users when they are approaching a crossing using GPS. (New York City)

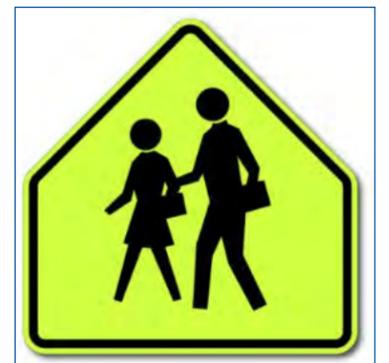
Figure 1.4: School crossing sign.

If requested, signing, as shown to the right, can be added at each campus entrance. Signing will alert the vehicles that pedestrians are possible, but will not lull pedestrians into a false sense of security.

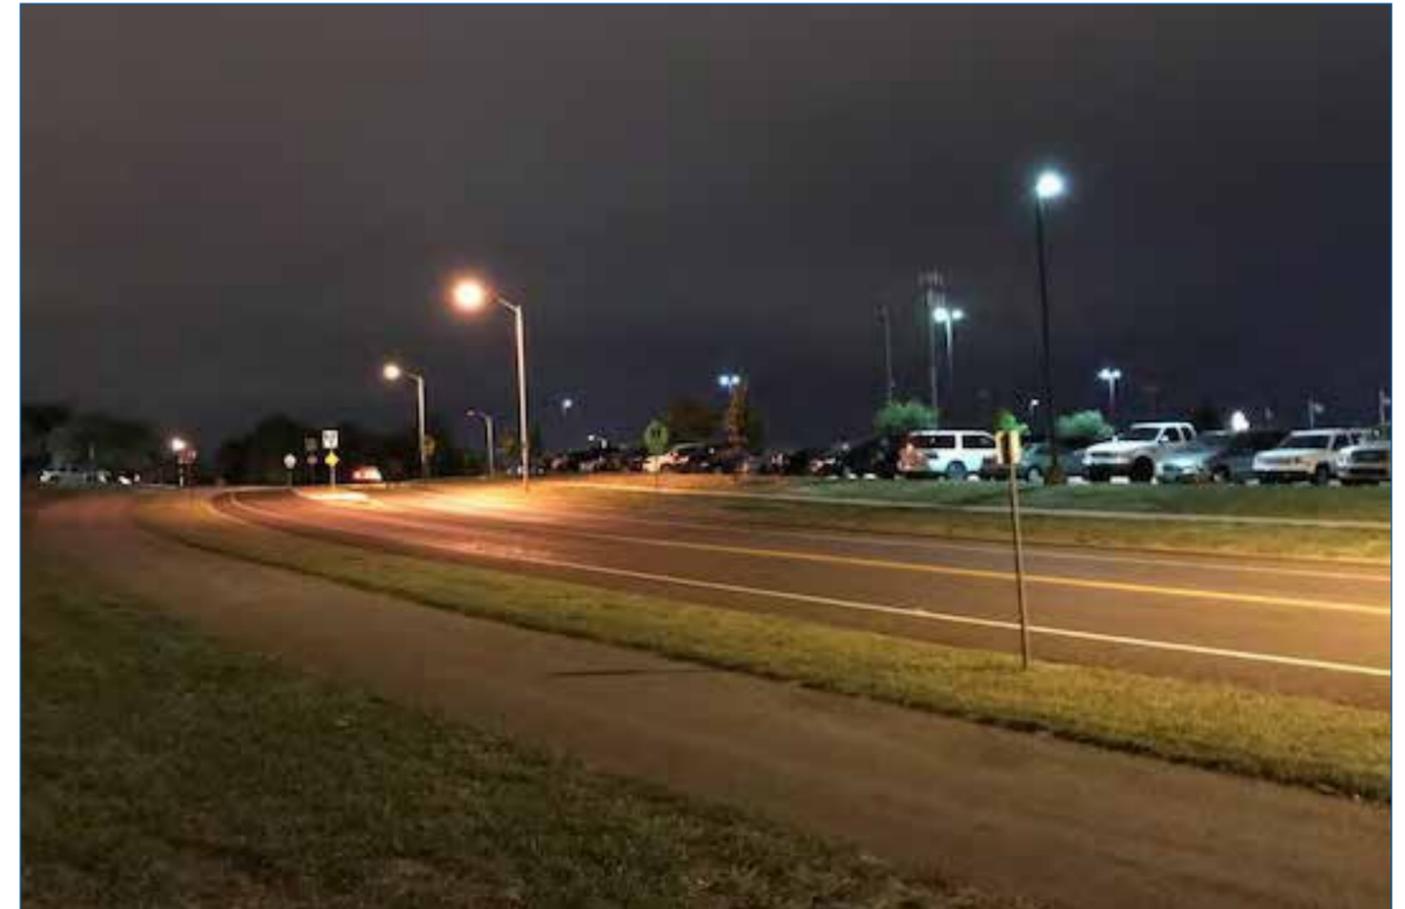
Figure 2.1: Crosswalk locations at Blue Valley High School.

Affinis staff collected pedestrian counts and made observations at Blue Valley High School (BVH) on February 13th, 2018. The crosswalk locations evaluated through this process are shown in Figure 2.1. Crosswalk locations 1, 2, 4, and 5 were counted, locations 3 and 6 were not. The AM (6:55am-7:55am) and PM (2:40pm-3:40pm) pedestrian counts are shown in Table 1. Locations 2 and 3 are unmarked. Affinis also met with campus police officers Burgess and Schmidt, who help patrol the campus daily.

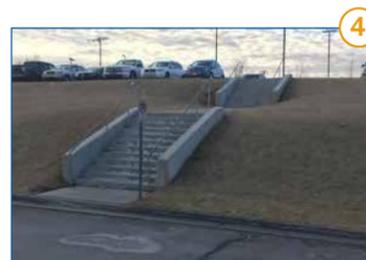
Figure 2.2: Existing conditions at Location 4.

The major and most concerning observation at locations 4 and 5 were the vehicles that traveled the wrong direction and sped through these locations. Roughly 15 drivers in the AM traveled in the wrong direction and 5-10 vehicles were observed speeding in the PM.

The greatest daily volume of pedestrians moving through the parking lots were at Locations 4 and 5. These two locations also drew the most concern when considering driving behaviors as well. We recommend adding speed tables at both crossings 4 and 5. This will guide pedestrians out of the building and to the stairs. Twenty percent of these pedestrians crossed the parking lot and walked up the grassy areas instead of using the stairs (Figure 2.2). To assist with guiding pedestrians up the stairs to create a more predictable path, we would recommend planting bushes or foliage (similar to Figure 2.4) at the tops and bases of these slopes.

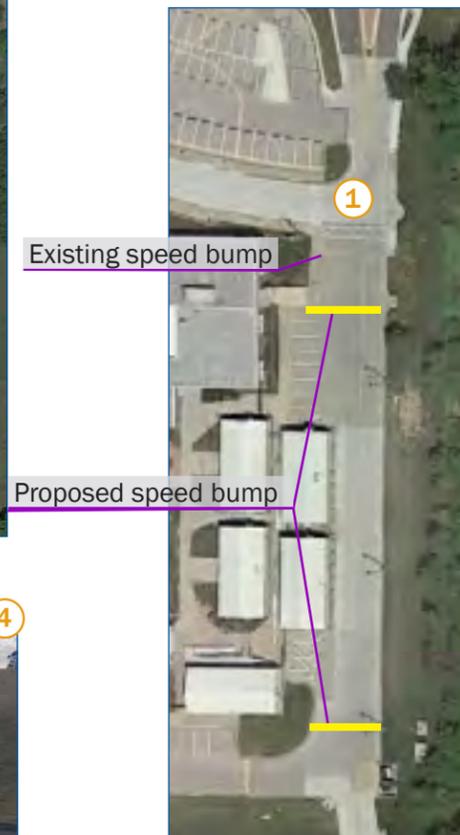
Figure 2.3: Proposed speed bumps south of Location 1.

In speaking with officers Burgess and Schmidt, they pointed out that a lot of pedestrians complain about vehicles speeding past the classrooms along the east side of campus. The existing speed bump located just south of the east-west crossing at Location 1 is excessively tall and caused most vehicles to come to a complete stop, which makes merging with pick up line traffic difficult. This north speed bump should be removed and relocated 10-15 feet south. An additional speed bump should be installed further south to assist in maintaining low speed traffic flow, as shown in Figure 2.3.

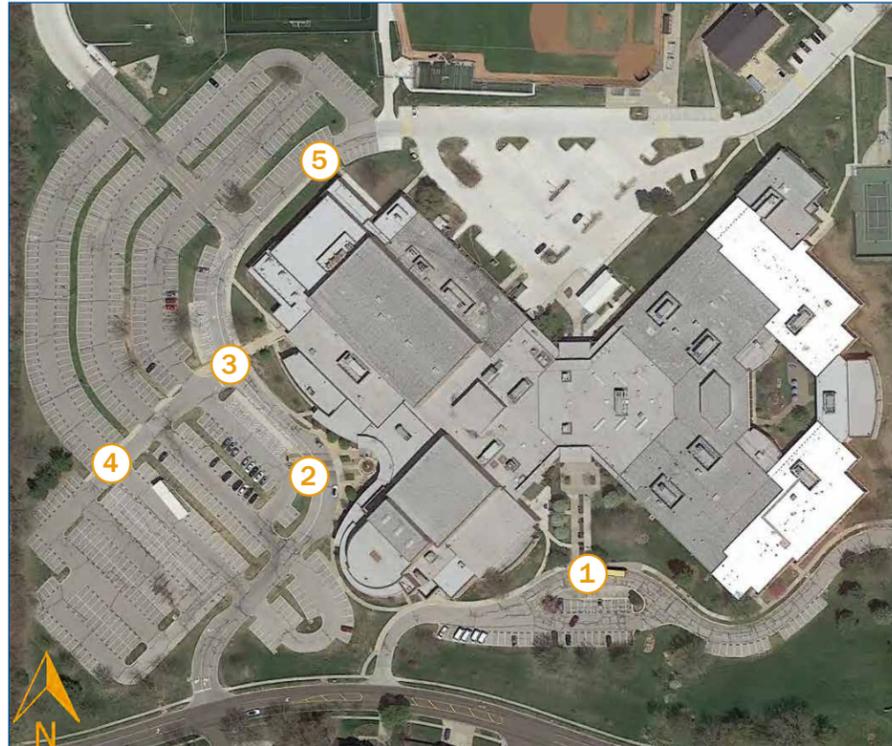
Figure 3.1: Pedestrian count locations.

Location 1 had the largest number of pedestrians crossing of any single location. This location was observed to be more adult (staff) pedestrians than student pedestrians. This crossing is a marked crossing and has an existing ADA compliant ramp. Of the 234 pedestrians in the AM, 215 crossed within the marked crossing. In the PM only 26 pedestrians crossed within the crossing, while 12 left the curb and headed directly toward their destination. The PM count volumes are likely lower because the staff does not leave during our count times.

Every crossing between locations 3 and 4 has the EUPD sidewalk messaging. Location 4 was counted in the AM, but it was determined that a PM count would not provide useful pedestrian data that would benefit our final recommendation.

Location 4 and all of the crossing between locations 3 and 4 do not have ADA ramps in their current condition. These locations do have EUPD. These crossing do not need to include ramps because they do not serve the ADA accessible parking.

Location 5 serves pedestrians as expected. This location acts more like a broad access to and from the parking lot from the northwest side of the building and there are no ADA parking spots located northwest of the building. This location should include the EUPD messaging.

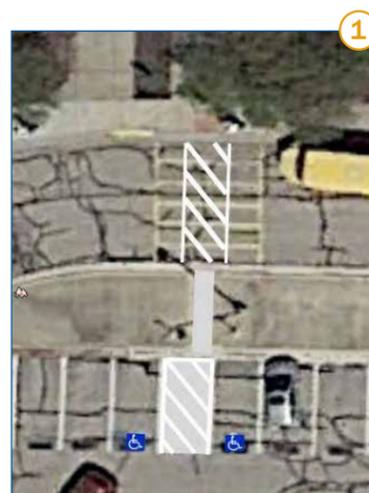
Figure 3.2: Location 1 improvements.

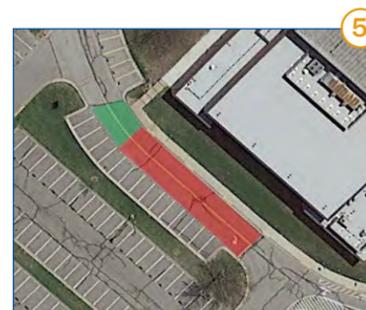
Figure 3.3: Green area was considered “in crosswalk” and red area was considered “out of crosswalk” for count purposes.

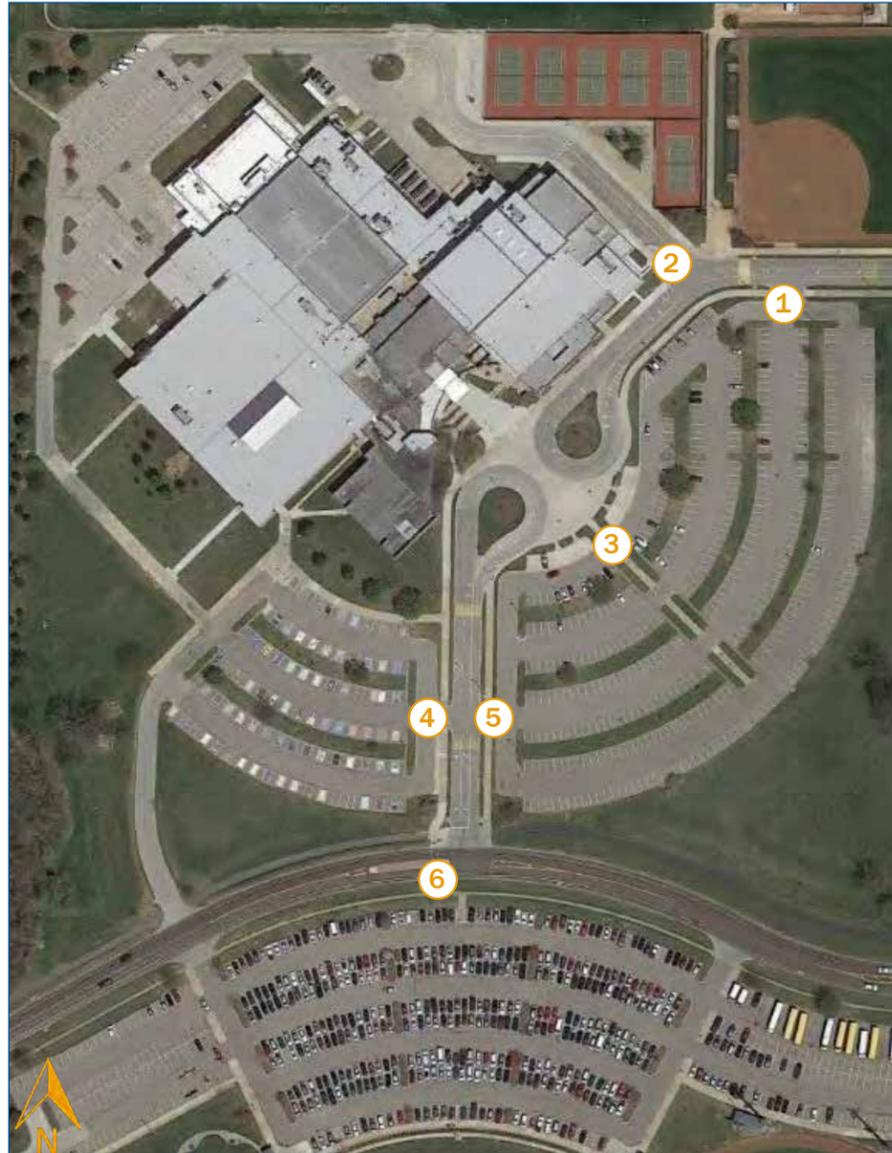
Figure 4.1: Pedestrian count locations.

Location 1 collects pedestrians onto the campus from the east. At this location we only observed one pedestrian in the AM and 0 pedestrians in the PM. This crossing has existing ramps but no ADA domes or crosswalk lines.

Location 2 was similar to location 1, in that it is a low volume crossing. In its existing condition it has ramps and EUPD messaging, but does not have ADA domes on the ramps. This is also not a marked crossing.

Locations 4 and 5 were observed, but not counted. Both of these locations have existing ramps and EUPD messaging. These two locations are not marked crossings and do not have ADA compliant domes.

Location 2 was observed to work well in its existing condition. This crossing should be updated to current ADA requirements, but otherwise maintained as it exists. Directly south of location 2, our team observed 45 students in the AM and 20 in the PM crossing in the red area on Figure 4.2. These pedestrians crossed between moving vehicles in an unsafe manner. These pedestrians seemed to be high school band members who were collecting instruments for an early AM band practice. There is not a direct access across the roadway near the area in the red in Figure 4.2. As shown, a speed table crossing could be added in this area to facilitate any pedestrians crossings here.

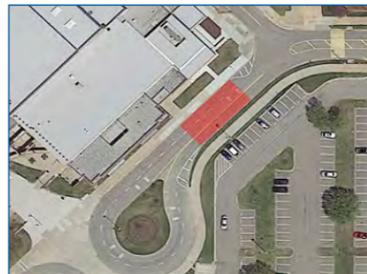
Figure 4.2: New speed table crossing.

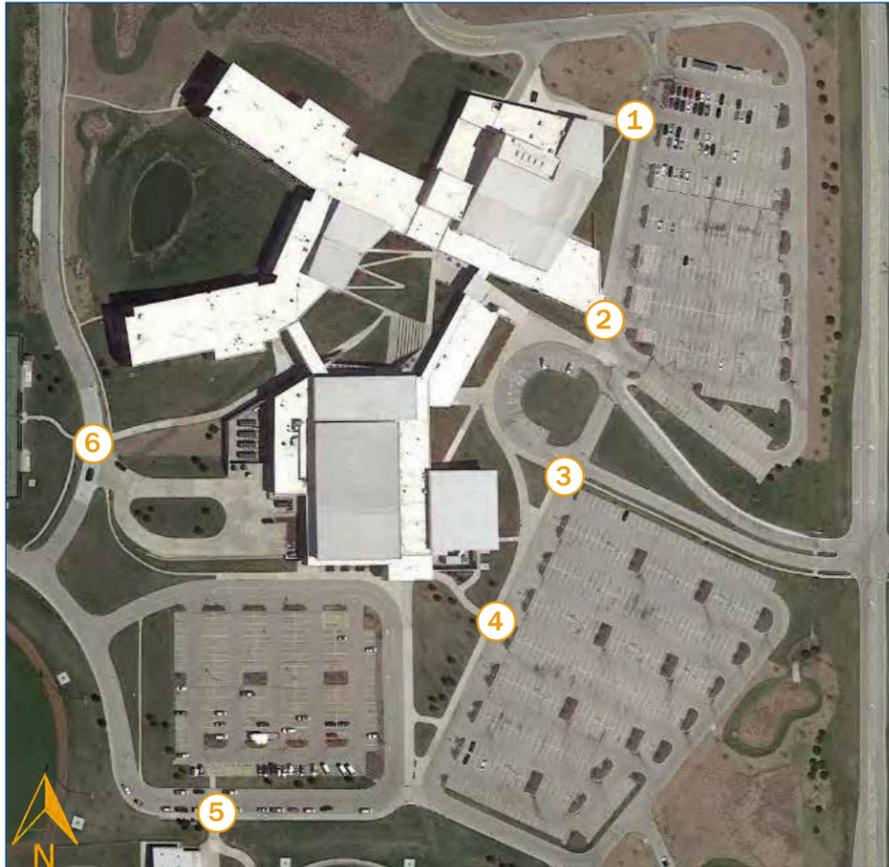
Figure 5.1: Pedestrian count locations.

Location 3 had 32 to 50 students crossing, to reach their cars parked on the north edge of the student parking lot. This location has a gate, but the gate was open in PM. This location should be marked if the gate is to be open during either arrival or dismissal. This crossing is the mixing point for the student parking and parent pick up line and once pedestrians are introduced at this location it can make for an unsafe environment.

Location 6 is already improved and seems to serve the pedestrians well in its current state, no additional improvements are needed here and it should be maintained as it is.

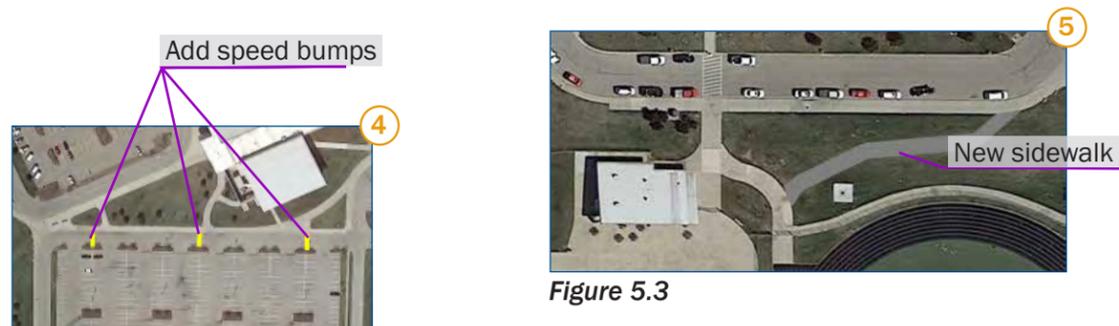
Figure 5.2

Location 4 should have an ADA ramp installed, but should not be a marked crosswalk. A marked crossing here would not serve the pedestrians well because they walk directly off the curb to their cars. However, three speed bumps along this crossing would ensure slower speeds, as shown in Figure 5.2.

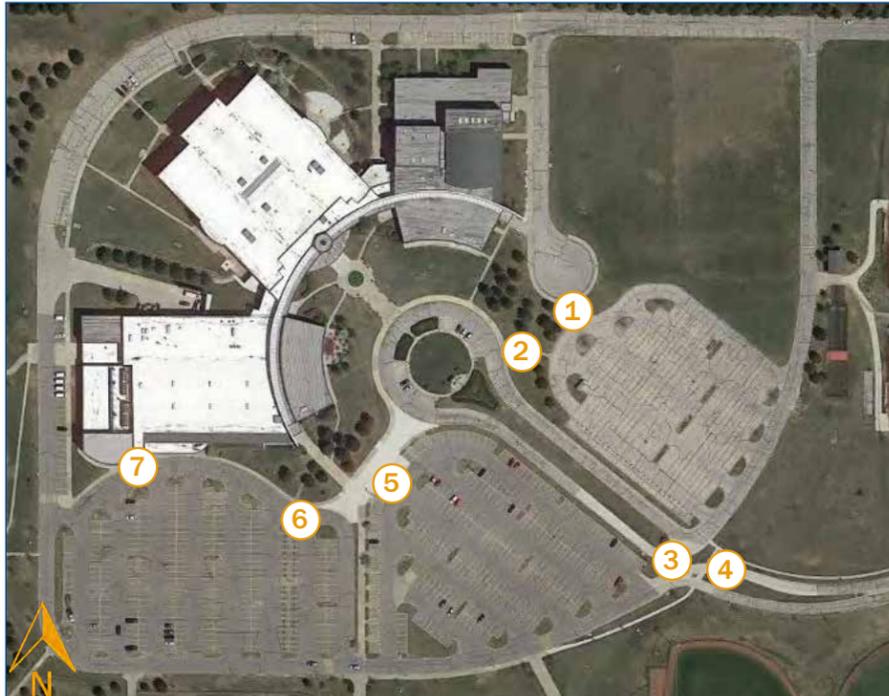
Figure 6.1: Pedestrian count locations.

Although locations 3 and 4 were observed to have very little pedestrian traffic during our counts, these crosswalks connect across the two main entrances and exits for the campus. These locations should continue to be maintained with the EUPD messaging and marked crosswalks, as well as brought up to current ADA requirements.

Location 7 is similar to location 5 in that it does not have or need a marked crosswalk. The EUPD messaging should be maintained at the ramp and the ramp should be ADA compliant, as shown in Figure 6.2. Adding speed tables on each side of the main crossing will increase safety at this location.

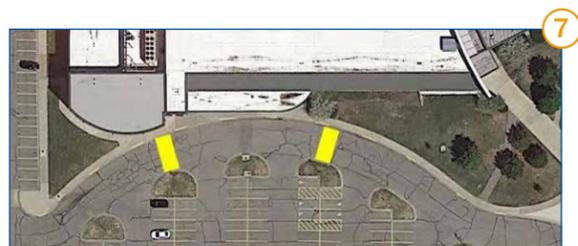
Figure 6.2: Location 1 improvements.

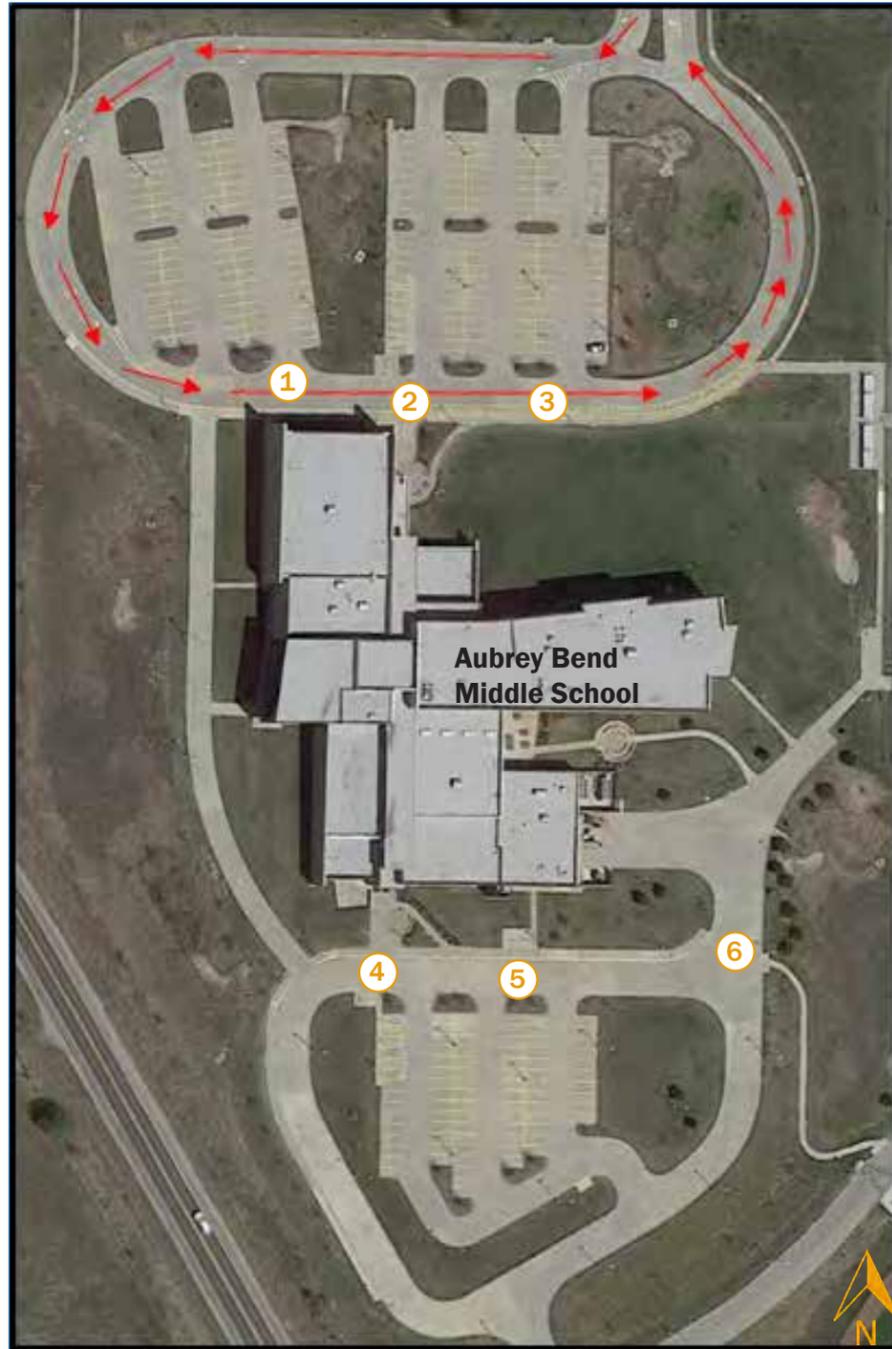
Figure 7.1: Crosswalk locations at Aubrey Bend Middle School

We also noted in the PM students crossing at Location 6 to head to cars parked along the roadway to the north of the baseball fields.

ABM works very well as it is currently setup. The only addition that would be beneficial is the use of the “Eyes Up, Phone Down” (EUPD) sidewalk messages. Those locations are shown below on Figures 7.2 and 7.3.

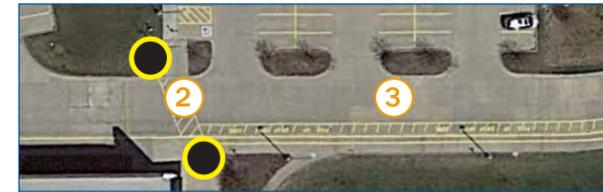
Figure 7.2: Proposed locations for addition of Eyes Up-Phone Down (EUPD) sidewalk messaging.

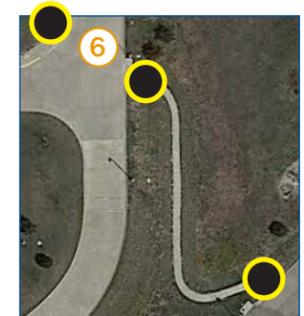
Figure 7.3: Proposed locations for addition of Eyes Up-Phone Down (EUPD) sidewalk messaging.

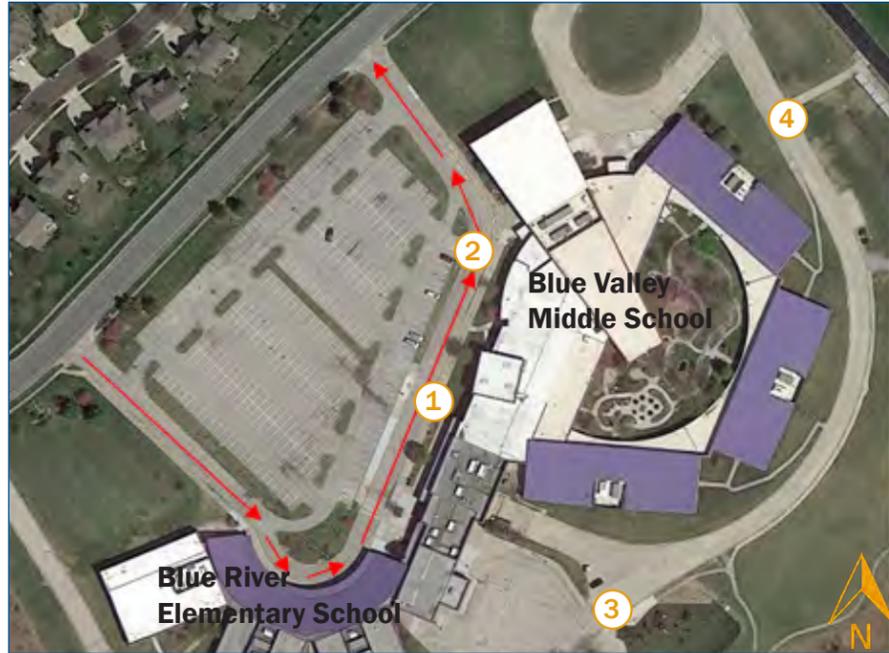
Figure 8.1: Crosswalk locations

Blue Valley Middle School is connected to Blue River Elementary School (BRE) to the southwest. School arrival and dismissal times are offset between the two to benefit both. All four crosswalk locations that were counted are currently marked, but are marked differently. Locations 1 and 2 have crosswalk edge lines and a diagonal crosshatch line, while locations 3 and 4 have only crosswalk edge lines. Locations 1 and 2 also have speed bumps preceding these crosswalks to assist in making sure the traffic flow slows. Like other middle schools and elementary schools observed, Blue Valley Middle School is very structured in its arrival and dismissal process. The current setup has the queue form on the outer loop of the north parking lots.

- ▶ Improve all ramps to be ADA compliant as improvements are made across campus.
- ▶ Add EUPD sidewalk messages at the locations recommended in Figure 8.2.

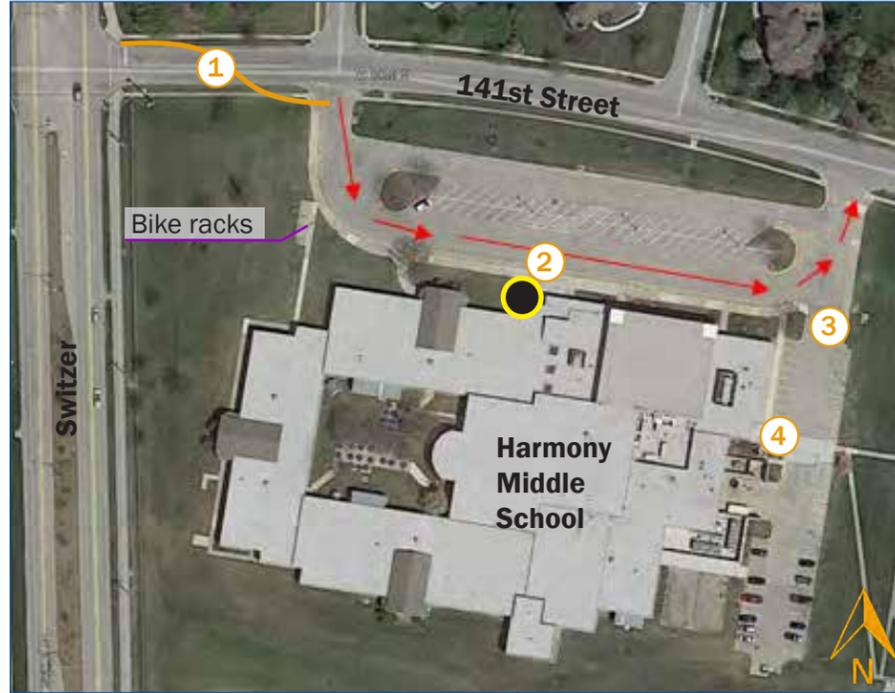
Figure 9.1: Crosswalk locations

Harmony Middle School (HMS) is located at the corner of Switzer Road and W 141st Street. The Affinis team did not collect pedestrian count data, as this school was visited on June 13th, 2018 and school was out for the summer. We did discuss key issues with the principal.

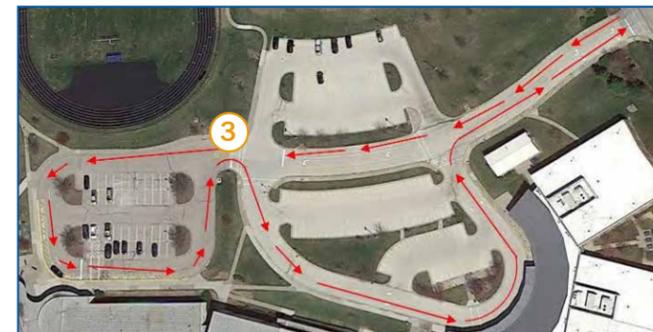
Figure 10.2: Arrival and dismissal traffic flow

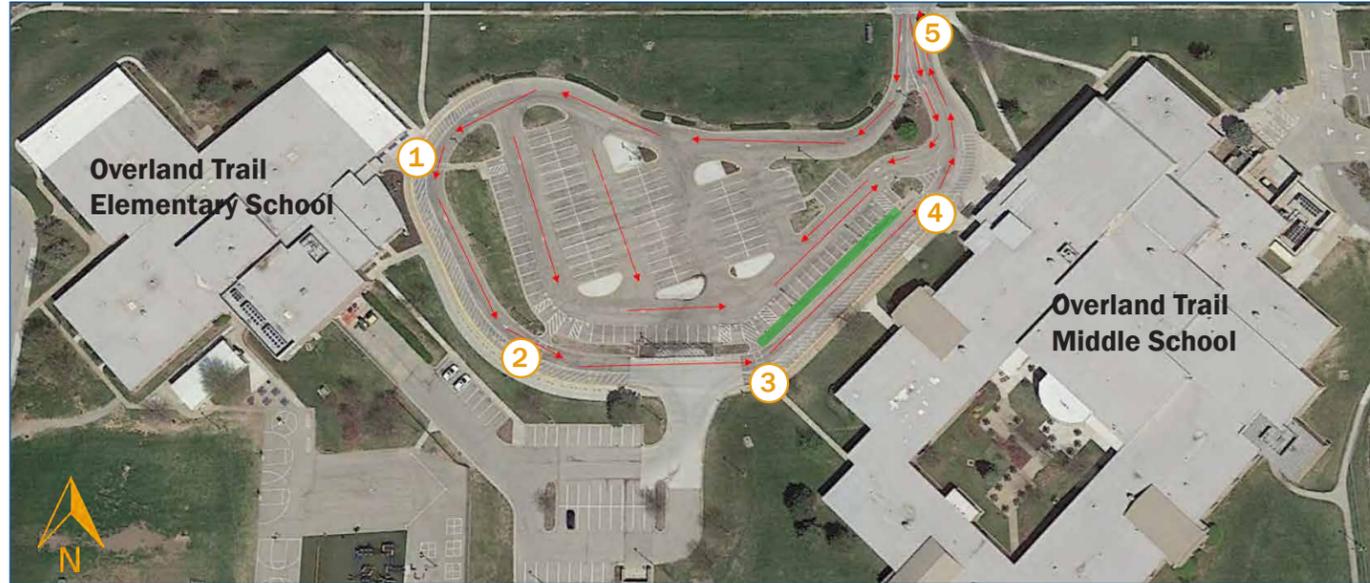
Figure 12.1: Crosswalk locations

There are four areas the team observed within the main parking lot between the two Overland Trail schools and one area of concern at the exit of the parking lot. The parking lots to the east and to the south are primarily staff parking and wouldn't require the EUPD sidewalk message. The small bus loop to the west of Overland Trail Elementary School does not have any additional parking, and should be maintained as it is.

Although Location 5 is signed to restrict outgoing left-turns, some parents choose to turn left, usually causing them to sit and wait on a gap and stopping all traffic in the pickup/drop off line. Adding flexible delineators in the pattern shown on Figure 12.2 will prohibit outgoing left-turns and keep traffic flowing.

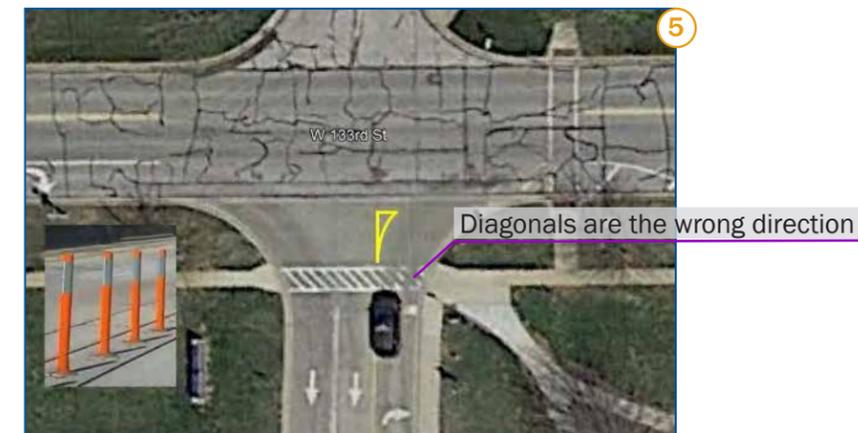
Figure 12.2: Improvements for Location 5

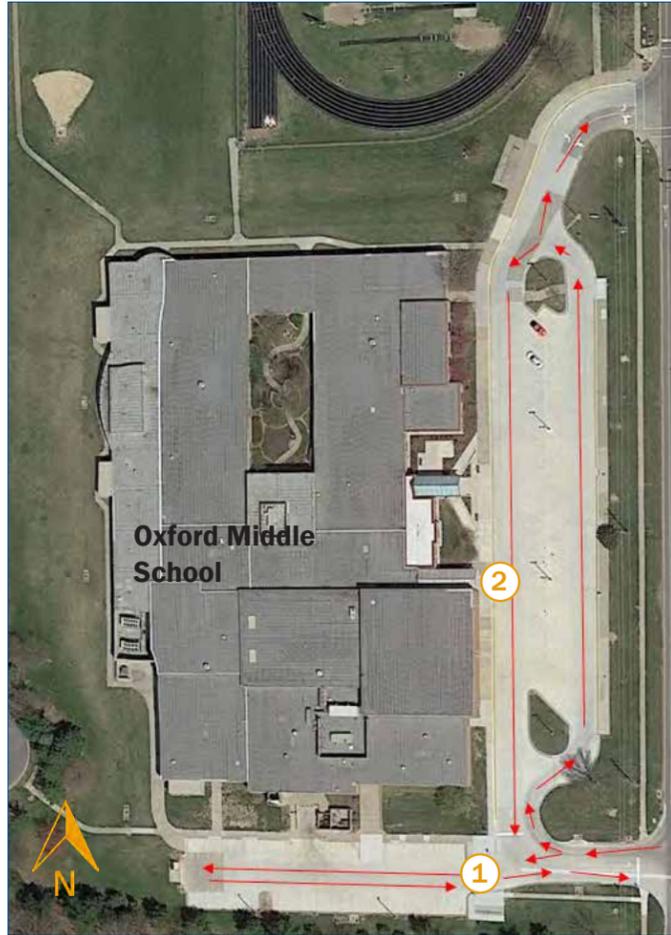
Figure 13.1: Crosswalk locations

The traffic flow through the parking lot is shown with the red arrows on Figure 13.1. The main staff parking lot is to the south of the building and general day traffic uses the parking between the building and Switzer Road. Location 1 is a marked crosswalk with ramps on both sides. Location 2 has a ramp that leads to the ADA parking spot, but is not marked as crosswalk.

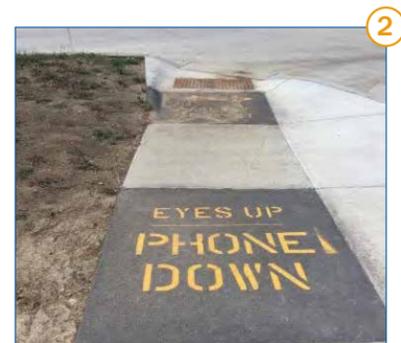
Figure 15.2

Location 2 is a great addition to this campus, but in our field review we notice that dirt was washing over the message during rains, as shown in Figure 15.2. Grass growing along the sidewalk here should fix this issue, but if it does not a short sidewalk curb would fix it. Because this location goes through the main connection between Prairie Star Elementary and Prairie Star Middle, as well as being adjacent to the pick up/drop off line it should be a marked crossing.

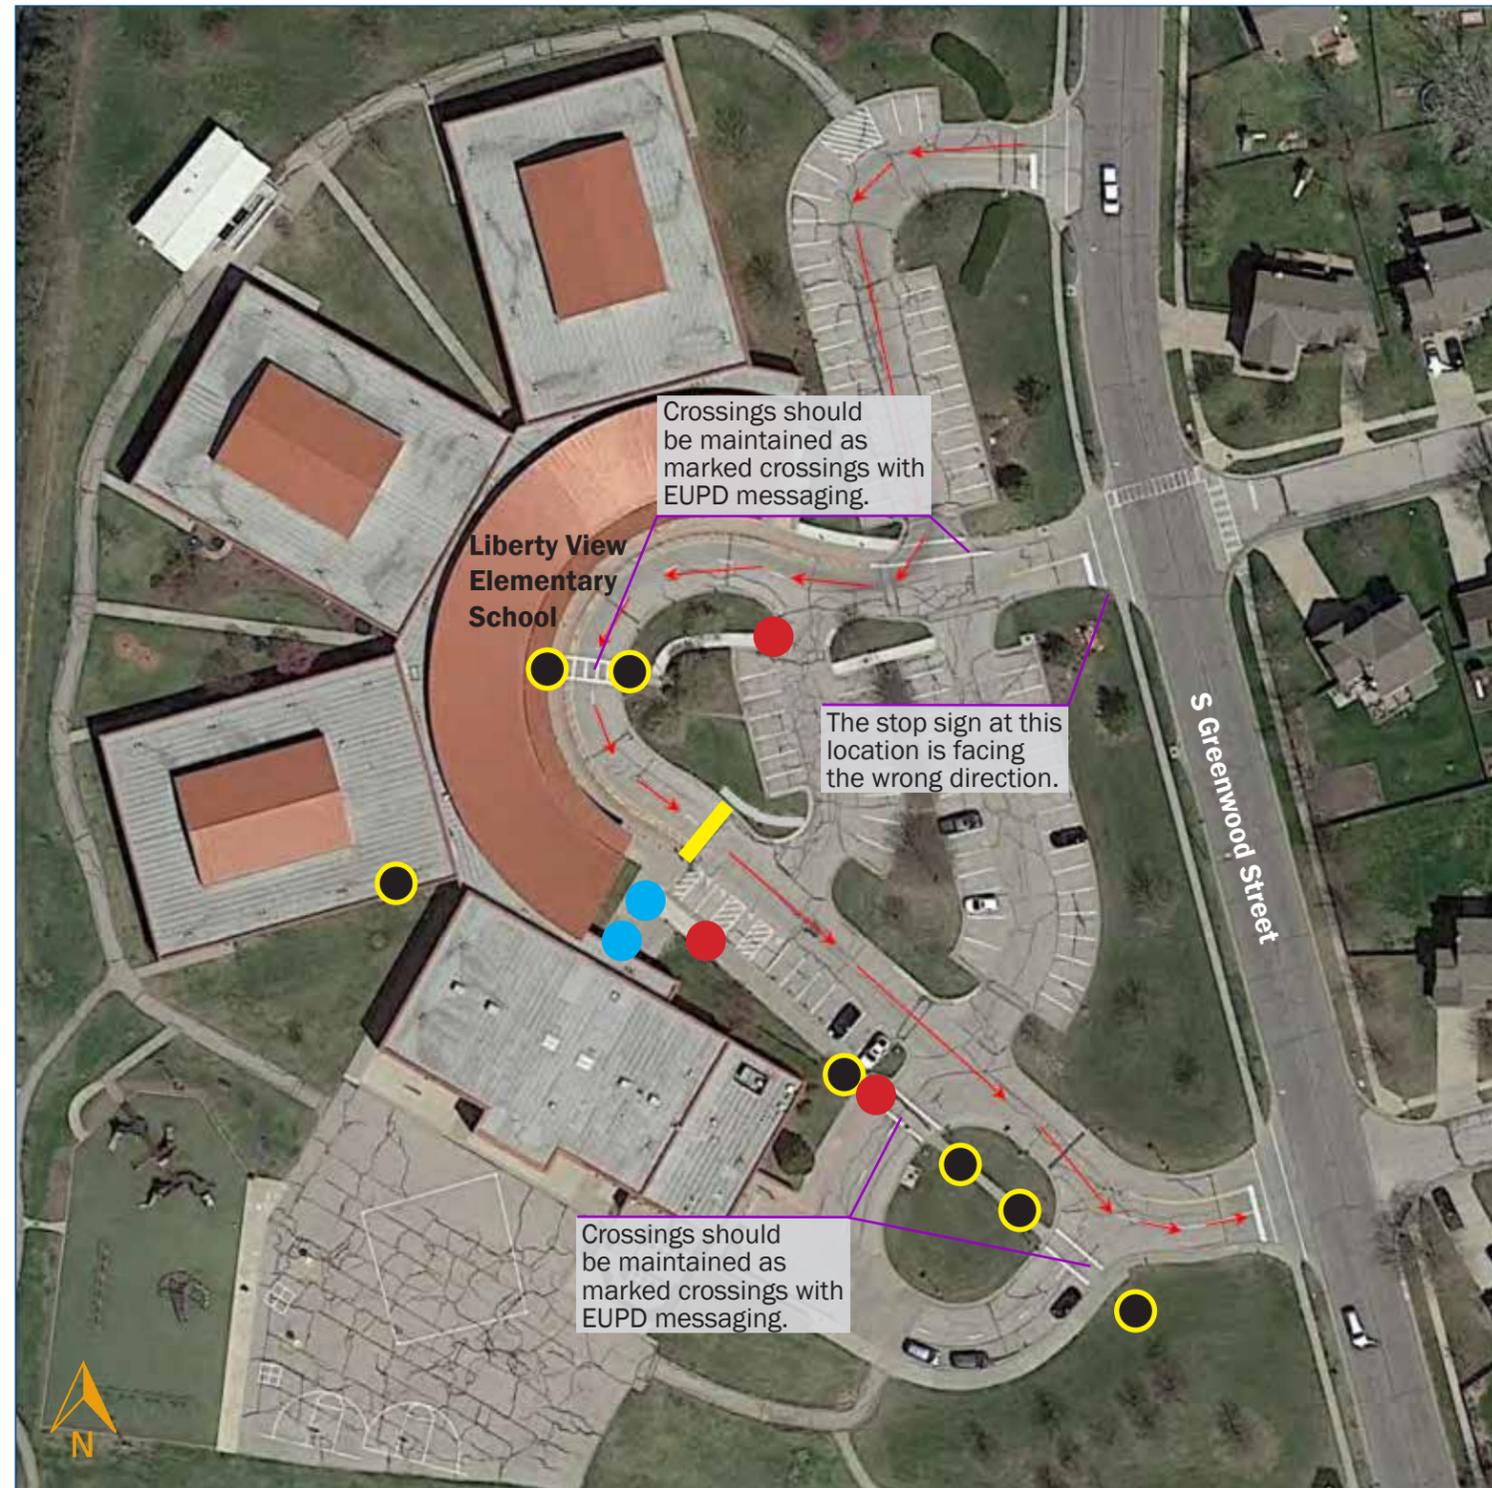
Figure 24.1

Existing left-turn causes major delay, consider right-in/right-out.

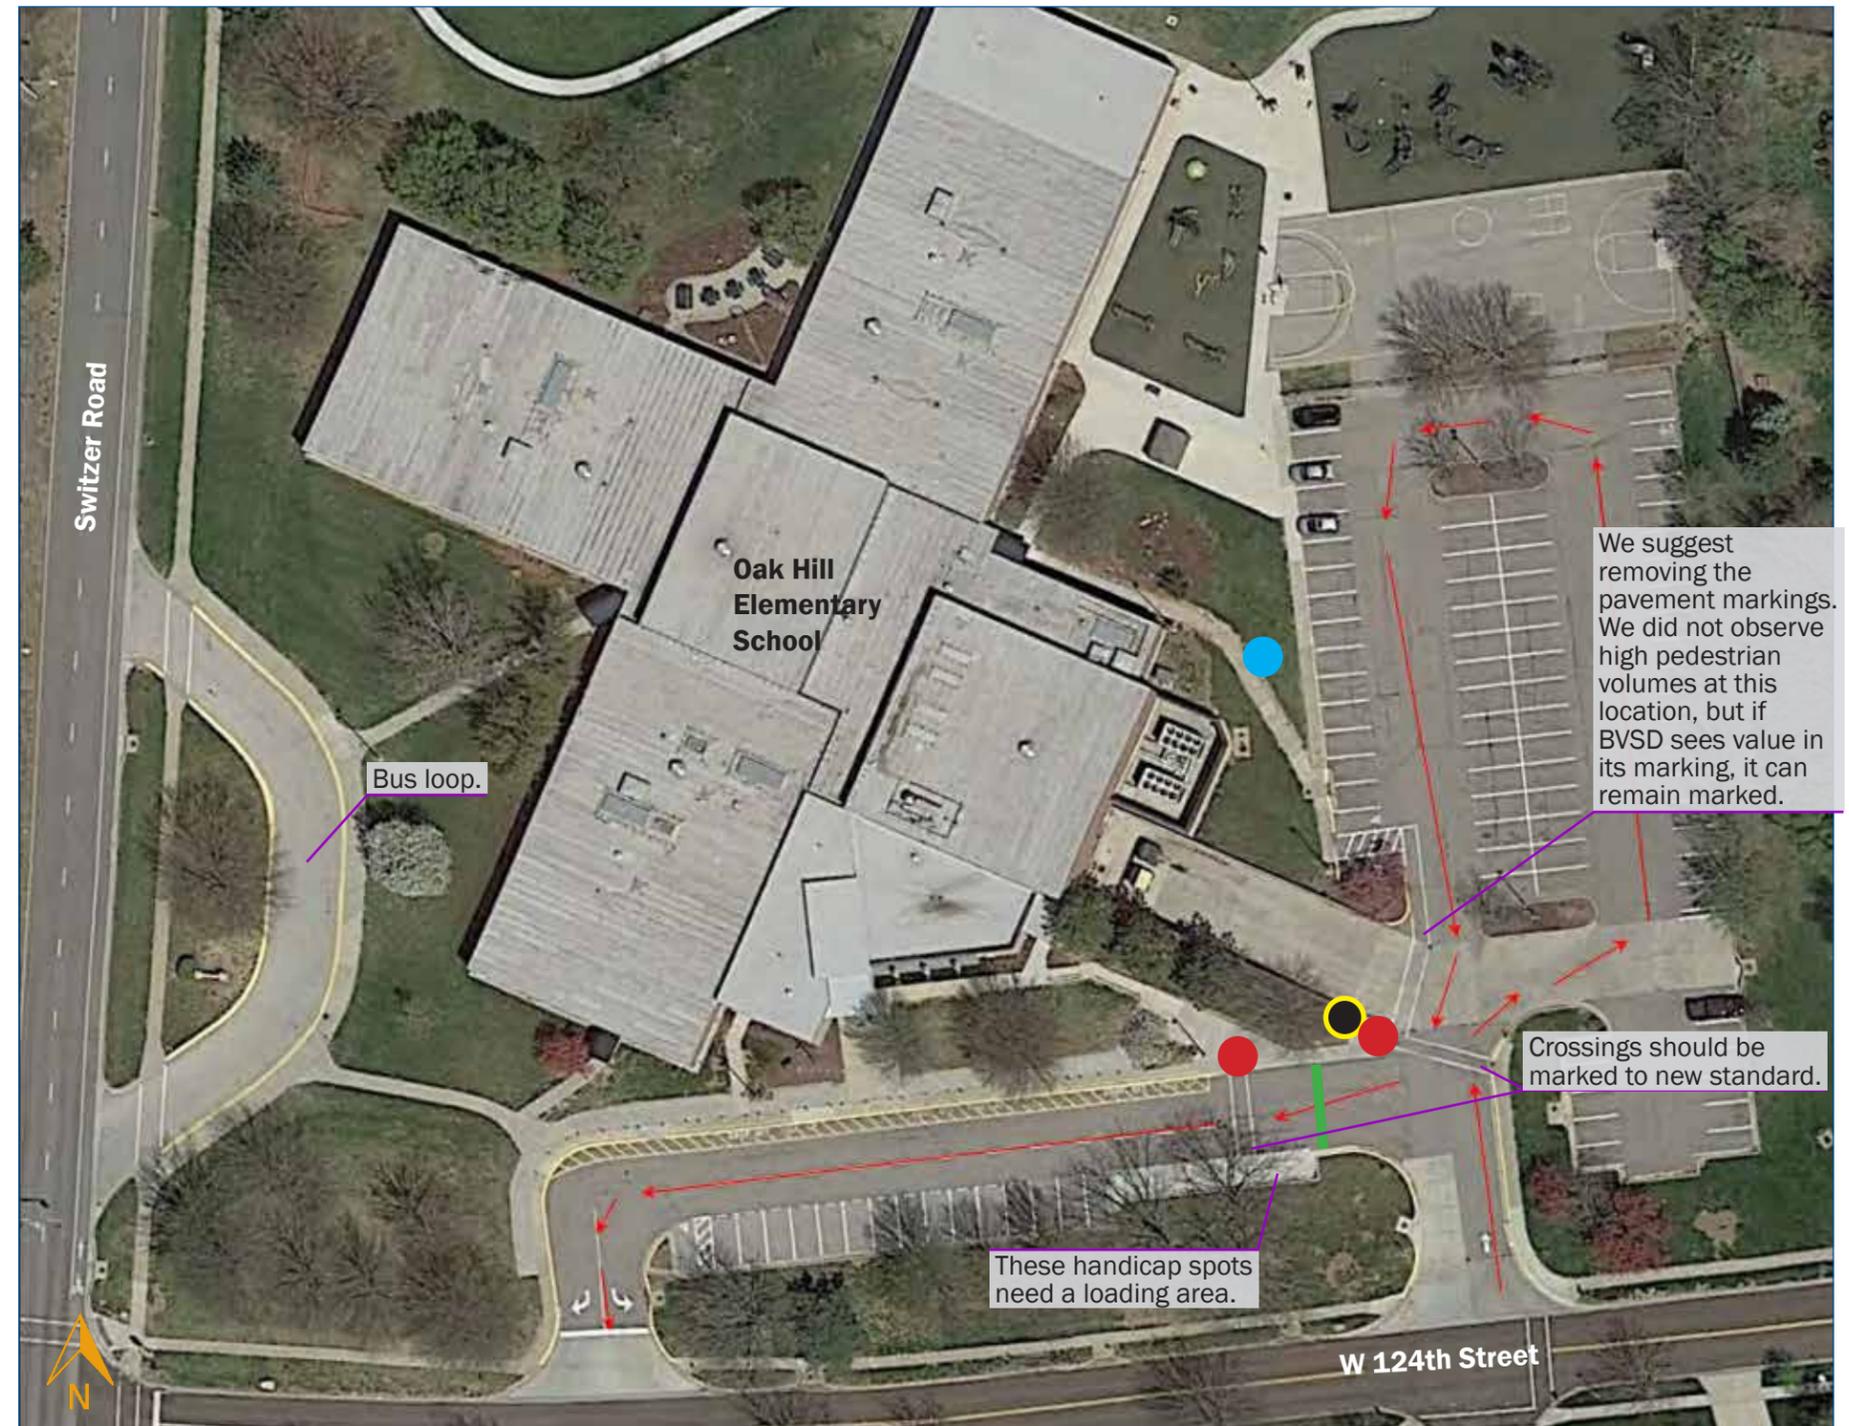
Figure 27.1

- Add ADA Crosswalk Ramps
- Add Speed Bump
- ← Estimated Pickup/Drop Off Flow
- Existing Bike Racks
- Add EUPD Messaging

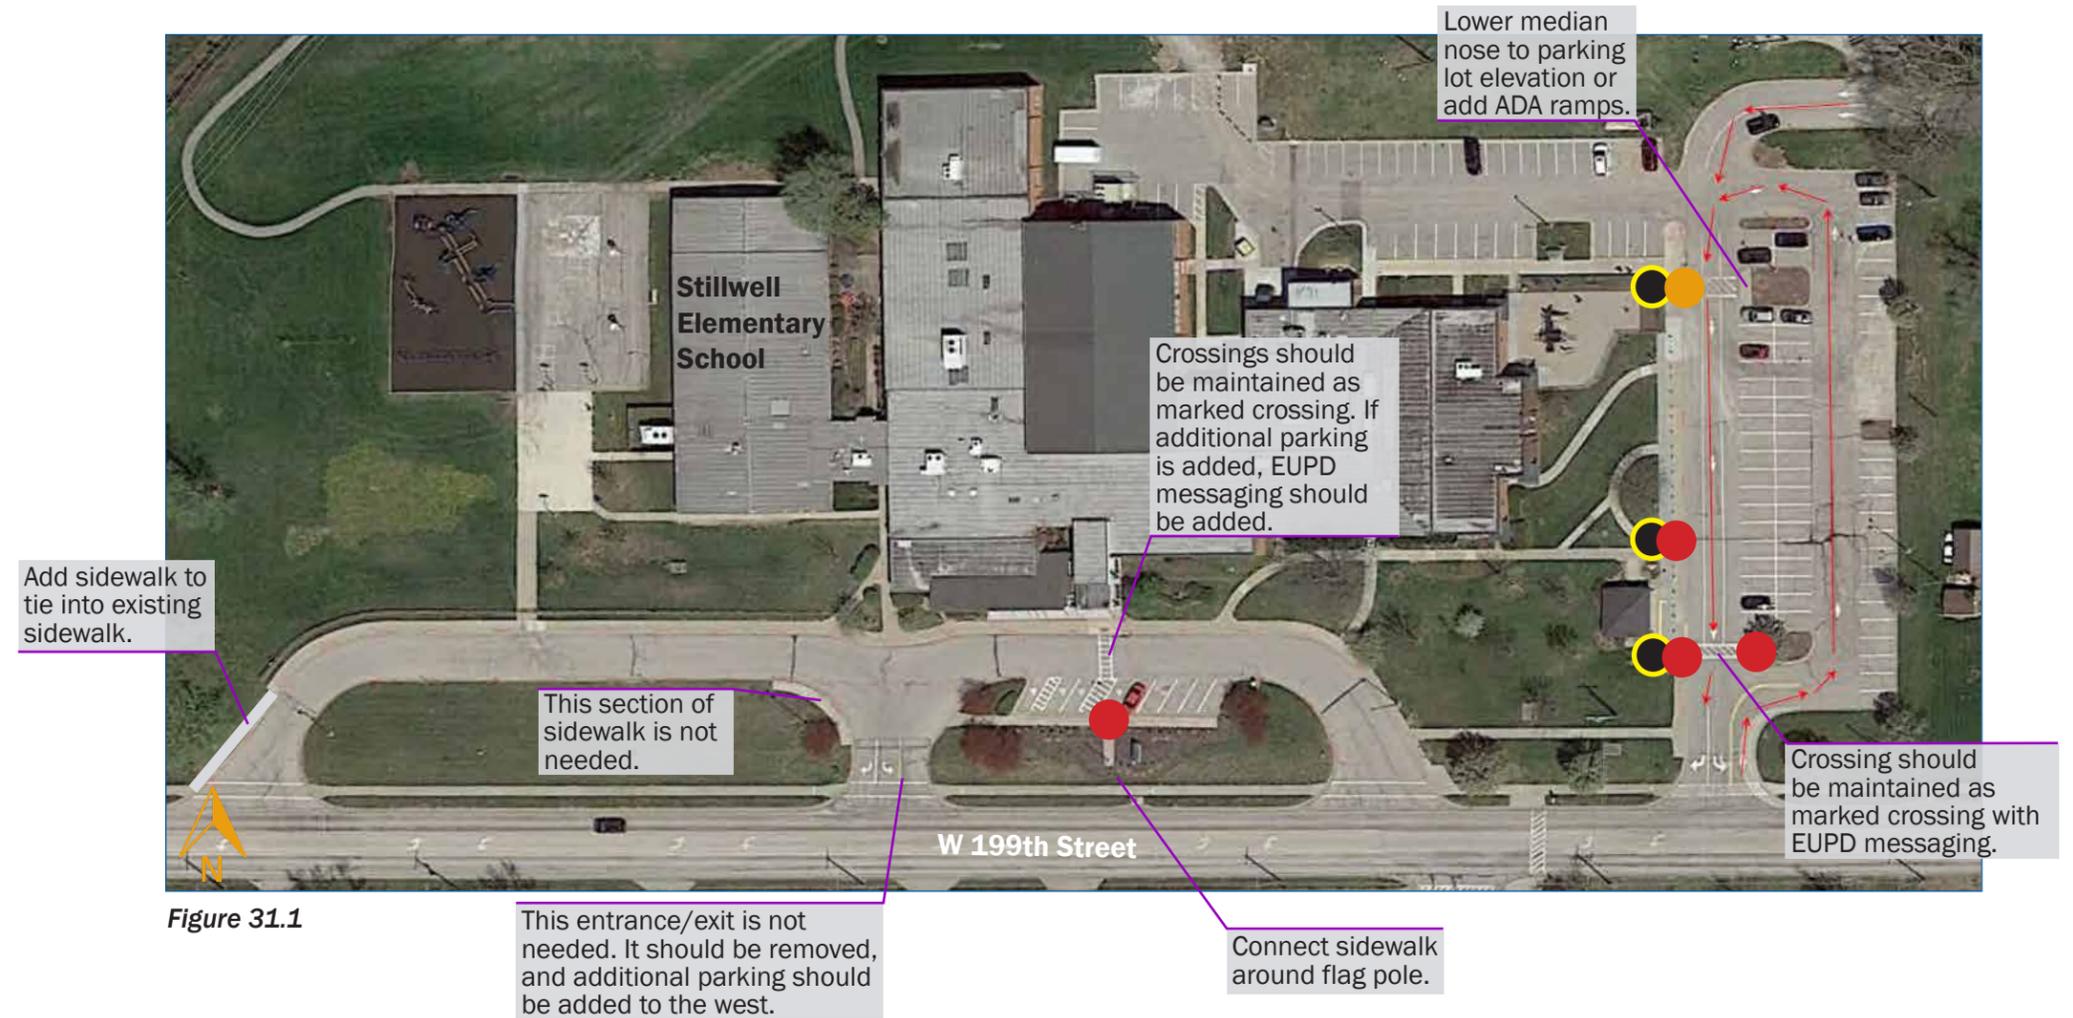
Figure 31.1

All sidewalk ramps are ADA compliant, but the ADA domes are brick pavers. The brick pavers can be compliant, but if pavers shift, they can increase/reduce the spacing between the domes causing the ramp to fall out of compliance. We recommend replacing with dome pads.
